## Possible cause of noise due to incorrect drip tray placement

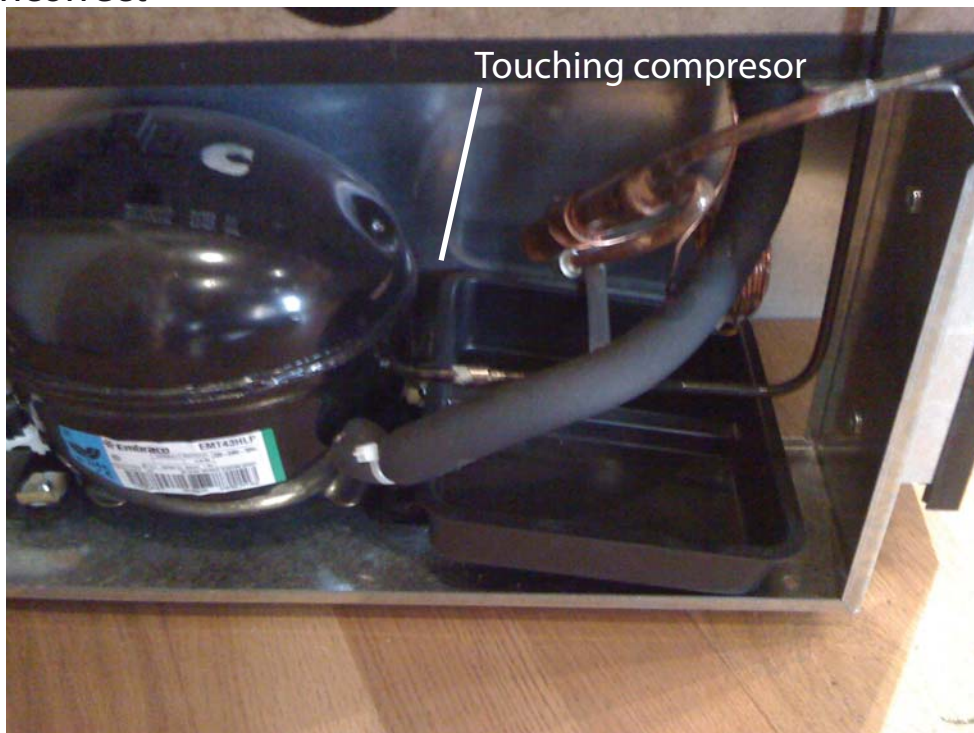
Incorrect
